Impact Analysis of Mining on Wetland Transformation in Rwanda

Ephrem HARERIMANA¹, Christophe Mupenzi¹

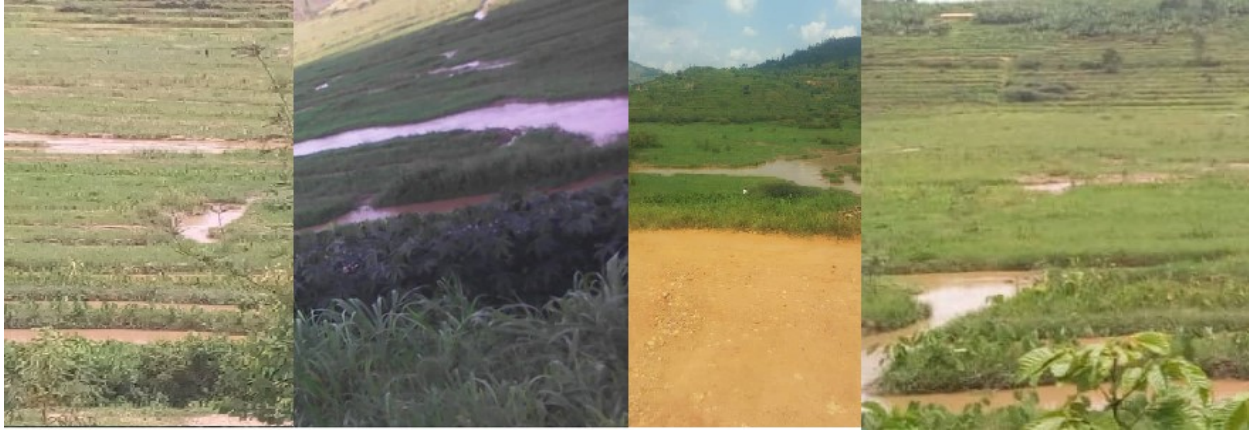
As a result of excessive siltation within the wetland and the river channel, crop failure is a common occurrence during the rainy seasons. The droughts following those rains also cause crop failure. During active mining, the majority of farmers shifted their agricultural activities to upland fields where they have regained the wetland, for crop cultivation, after that Havilla mining company stopped mining activities. The cultivated plots of farmland in 2000 covered 43.52ha (34%), 33.664ha (26.3%) in 2011 and 51.84 ha (40.5%) in June 2020.

Figure 7: Siltation, flooding and crop failure. However, Floods are somehow vital part of many ecosystems (including connectivity between rivers and their plains, bringing water and nutrient-rich sediment that produce fertile soils, habitats for birds, spawning grounds for fish and natural irrigation that provides lush pastures for livestock), Large floods can be very destructive and lead to damage to property, agricultural land and infrastructure and in the worst case, loss of life (Zedler & kercher, 2005).

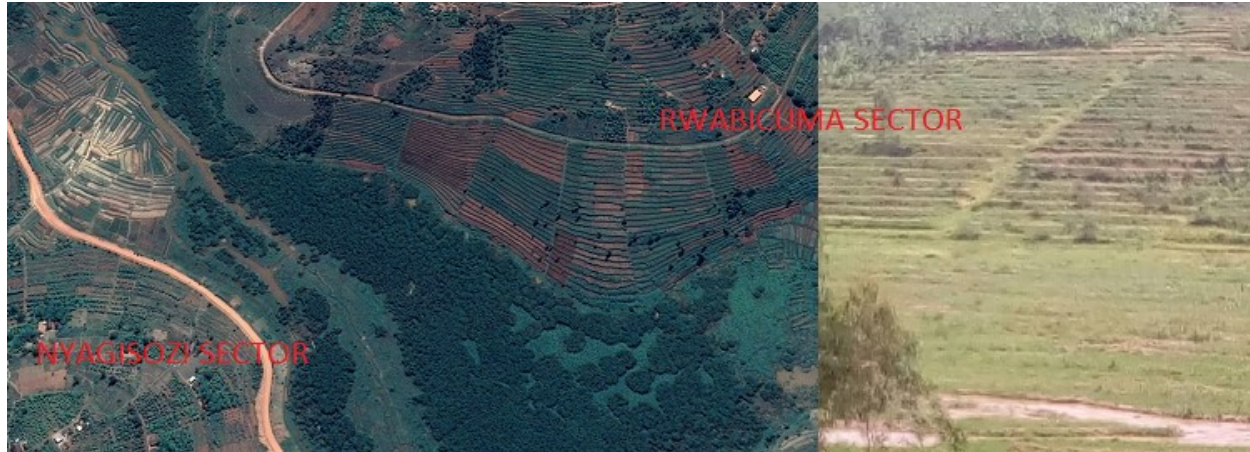
Mining activities have imposed great transformation to wetland ecosystems. In 2016, a buffer of 100m, around the wetland boundary, was leveled for radical terraces in order to minimize the additional disturbances through rapid surface runoff of rain water. As a result, the run-off capacity was controlled

and this has somehow facilitated the farmers to reclaim the damaged plots of farmland, day by day.

Figure 8: Radical terraces around the boundary of Mwogo wetland.

Radical terraces have the potential of improving of farmers „livelihoods and increasing the resilience of a degraded environment including the wetlands. After establishing a terrace, a riser is shaped and grasses or shrubs/trees are planted soon after (RNRA, 2017).
